EVALUATION OF AVAILABLE FOREST ROADS: A CASE STUDY

In this study, for each of the forest roads, technical characteristics, economic characteristics, characteristics of the road through which the road passes and disturbances on the roadside were assessed., the forest roads of the Gerede Management Directorate Aktaş Operation Chief affiliated to the Bolu Forest Regional Directorate in Turkey were handled in terms of "scoring and evaluation of existing forest roads".

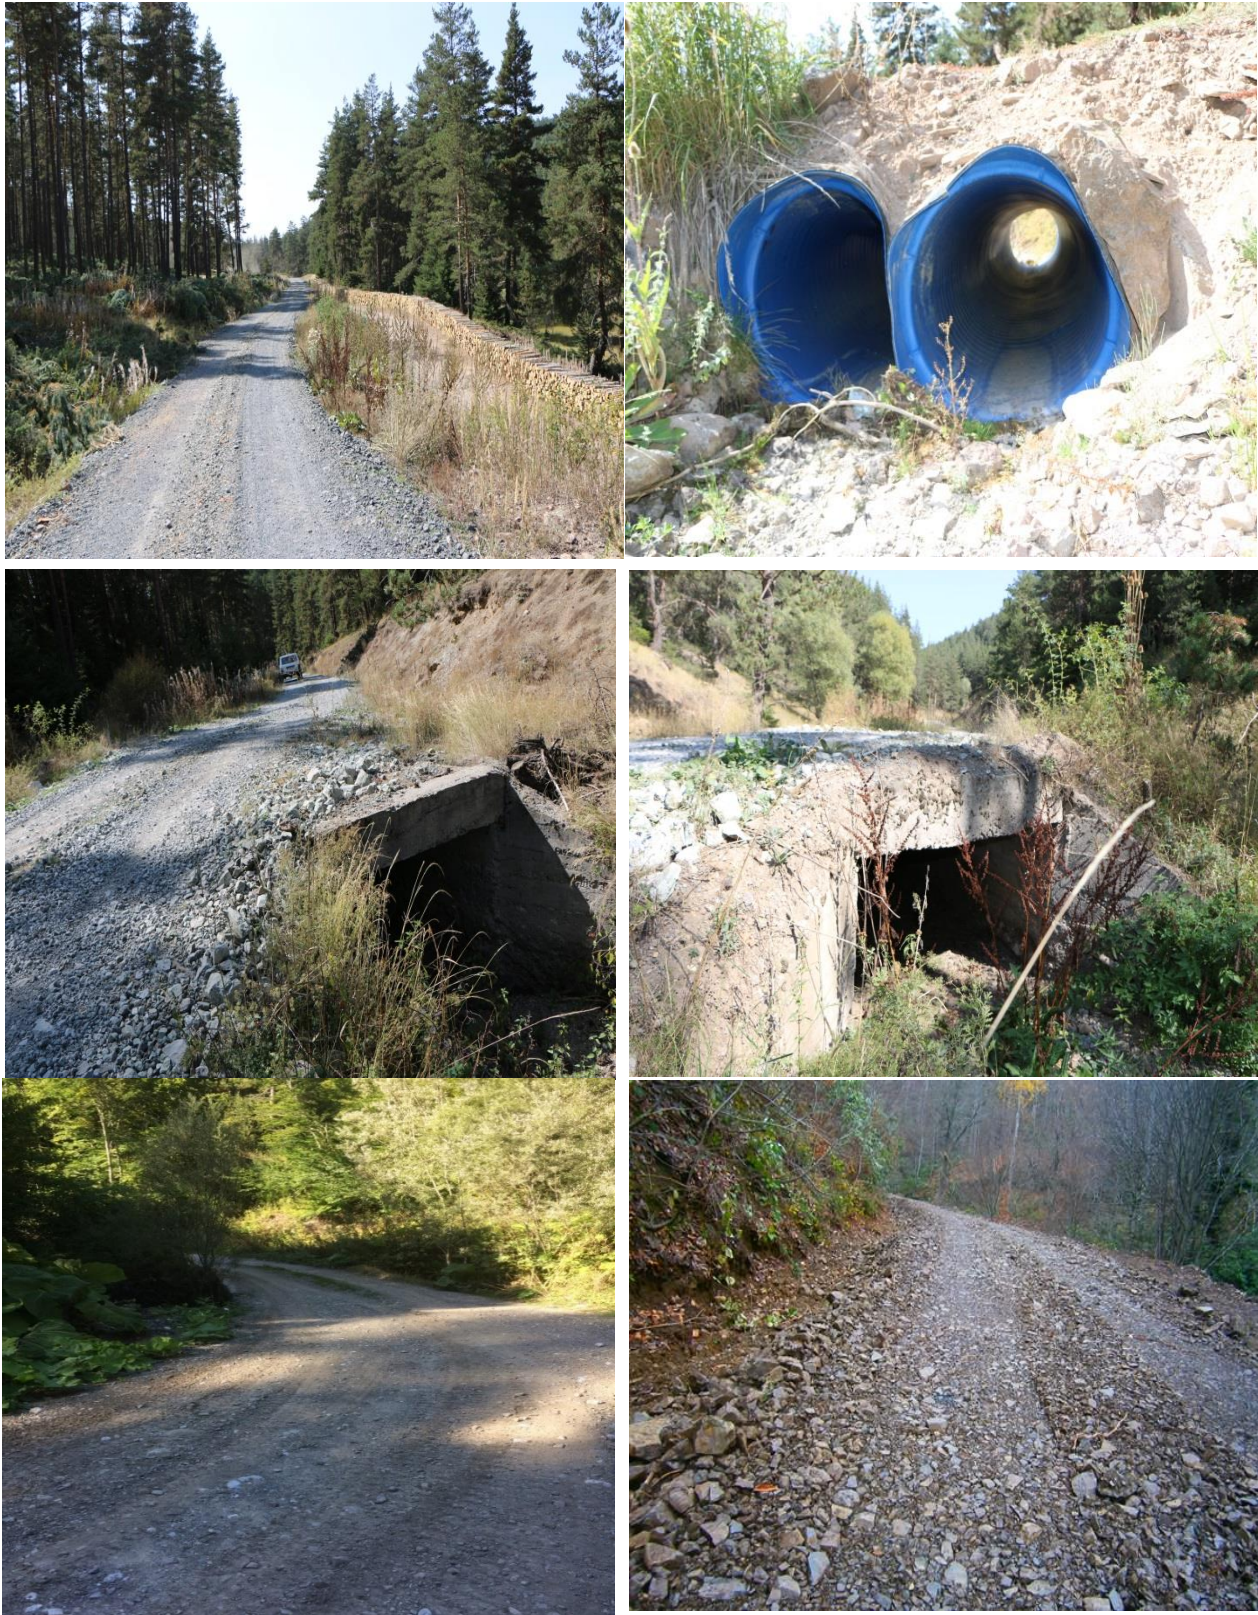
Figures 1. Images from investigating forest road

339, 336 and 357 on the forest paths of some of the art structures of the dry creeks due to floods are blocked and deformed. In some parts of forest road code number 357, deformations of dry streams along with flood waters were observed.
